**To:** Cambridgeshire County Council General Purposes Committee  
**Authors:** Richard Cushing and Edward Leigh, Smarter Cambridge Transport  
**Subject:** Review of Capita report and recommendations on guided busway defects  
**Contact:** 01223 312 377 / [edward@smartertransport.uk](mailto:edward@smartertransport.uk) / [@SmarterCam](https://www.facebook.com/SmarterCam)

# Cambridgeshire Guided Busway Defects

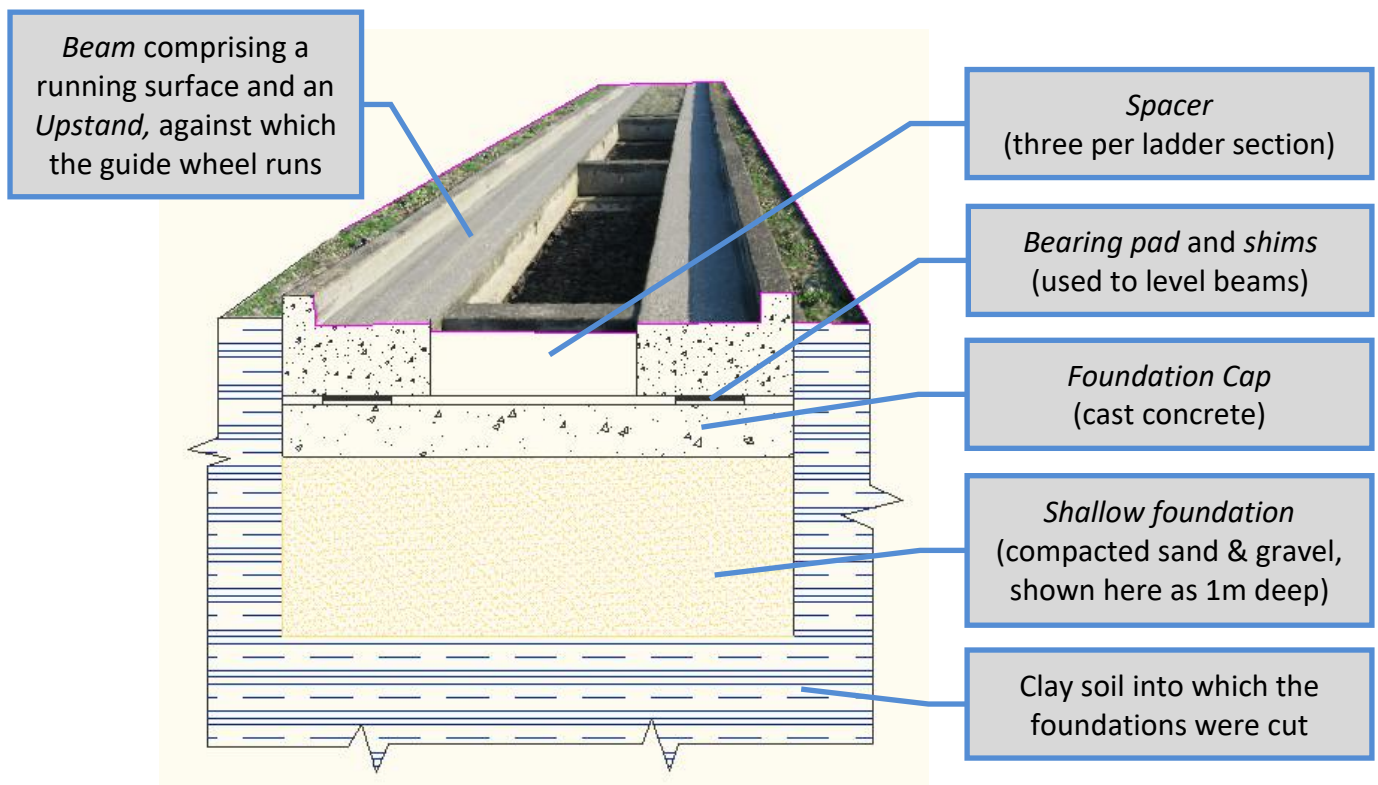
Figure 1: Cross-section of the busway showing a typical 15m 'ladder section' and one of three shallow foundations.

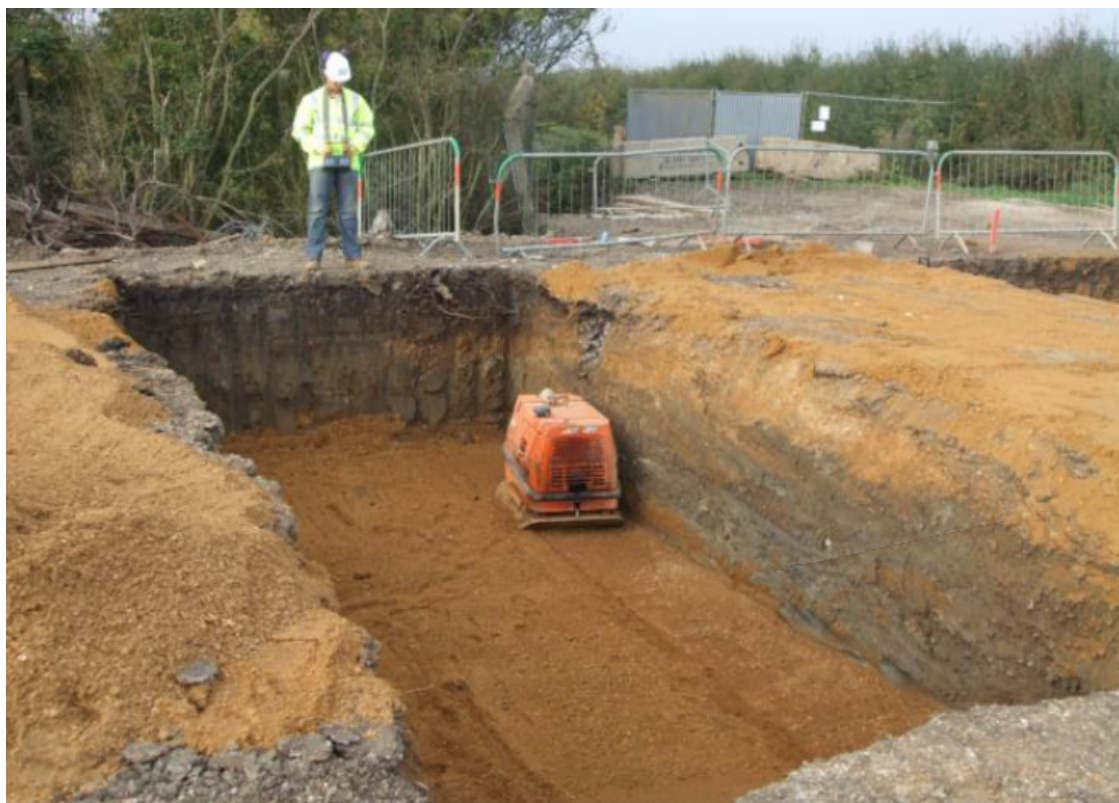
Figure 2: Shallow foundation [2-Fig 7]. 821 of these are to be re-excavated, deepened and re-instated

The size of the 'shallow' foundations are noted in the 2014 report [1 – p7, Fig 7], reproduced above (Fig 2). It would appear from the photograph that the volume of material present in such a foundation would require several journeys by heavy vehicles to remove it. The report notes that 821 of these foundations are to be excavated, deepened and re-established, using compacted Class 6N fill. It is unclear whether all of the excavated material will be removed from site and fresh material brought to the site, or whether some of the original material may be re-usable.

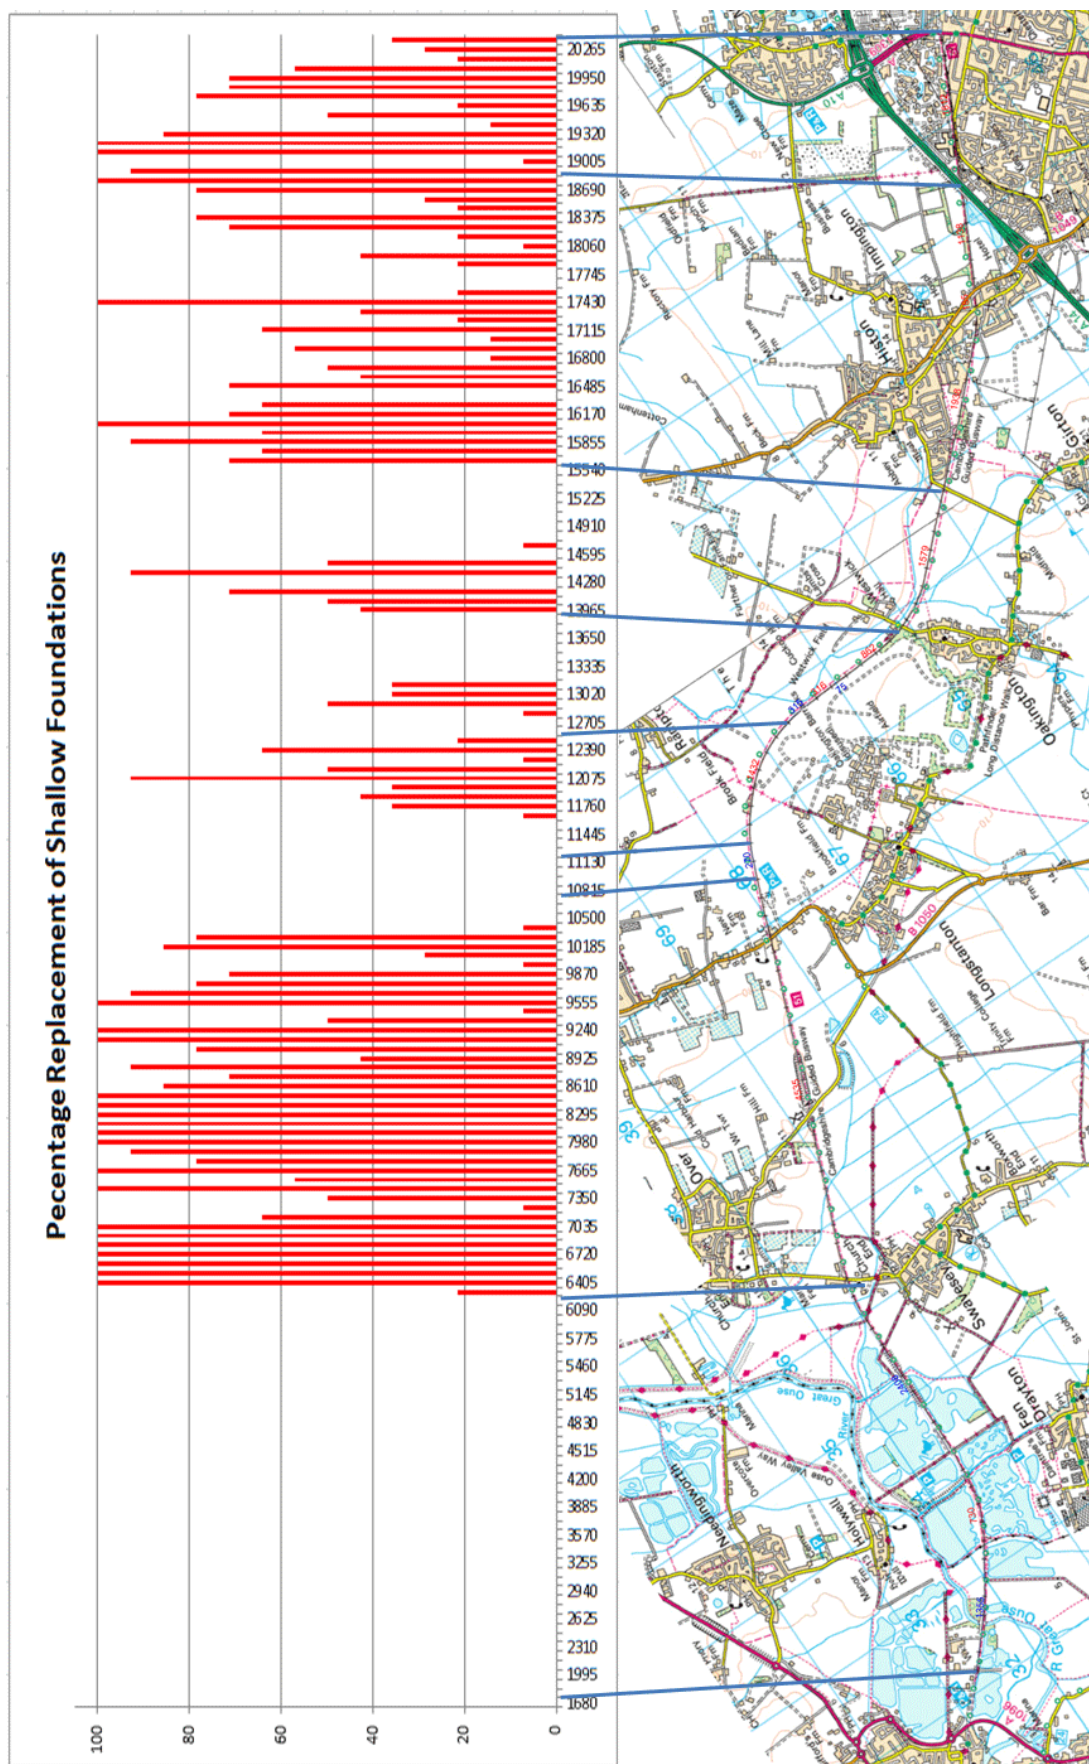
Figure 3: Location of foundations to be replaced. Piled foundations shown in blue, shallow foundations in red.

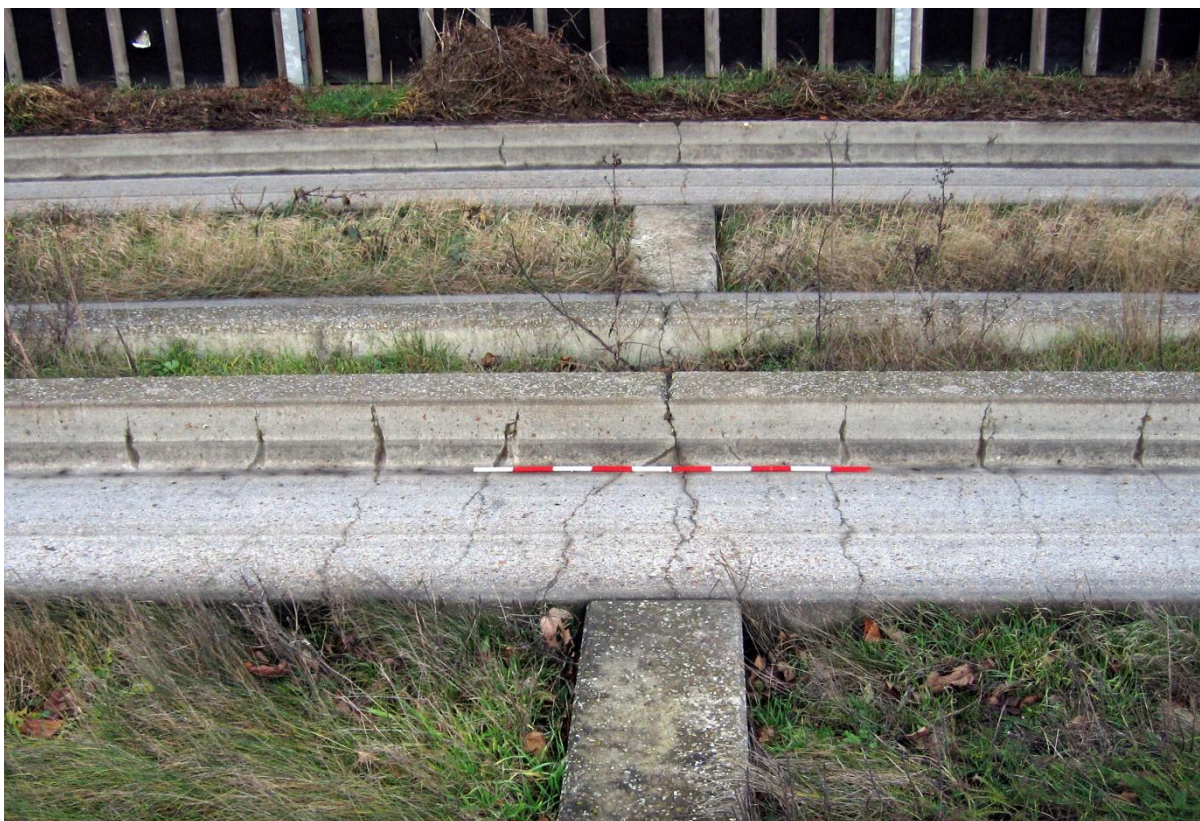
*Figure 4: Centre of guide rail, showing V-notch and cracking. Scale bar: 1m.*

Figure 4 shows part of the St Ives-bound guideway in the foreground, with the Cambridge-bound guideway behind. The length of beam in the foreground is approximately three metres. This pattern of cracking is typical of many in the Histon area.

Without treatment these cracks will worsen due to freeze-thaw and other factors. The report suggests injection with resin, and treatment with bitumen paint [2 – p41, para 142-3]. Given the extent of cracking shown above which has appeared within five years, it does not seem likely that this treatment will extend the life of the beams for a further thirty-five years. It is also noted that the amount of cracking is variable, but the degree of cracking at any location along the route is generally mimicked in all four beams.

***Is it the case that the cracking shown in the beams in Figure 4 is caused by heave in the centre of the beam or is there some other explanation?***

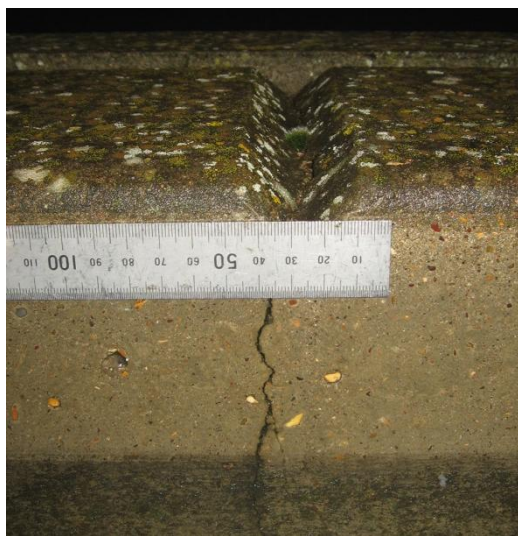
Figure 5 shows a crack in one beam. At the top of the upstand, adjacent to the V-notch, the crack was measured at 0.6mm wide. This gap in this beam has occurred over five years.

*Figure 5: Crack originating at V-notch. Measured photogrammetrically as 0.6mm.*

The report suggests treatment with resin and bitumen paint [2 – p41, para 142-3].

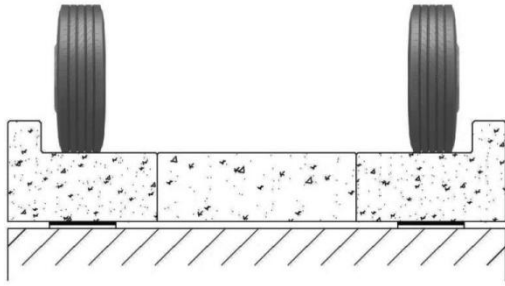
Figure 6a: Front wheels load the beams above the bearing points.

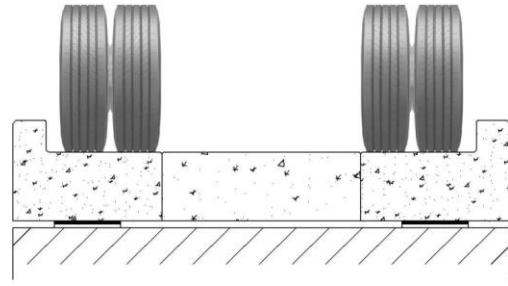
Figure 6b: Rear wheels create an offset load on the bearing stack, causing the beams to roll. This puts stress on the beams, spacers and fixings, and tends to force the stack outwards as shown below.

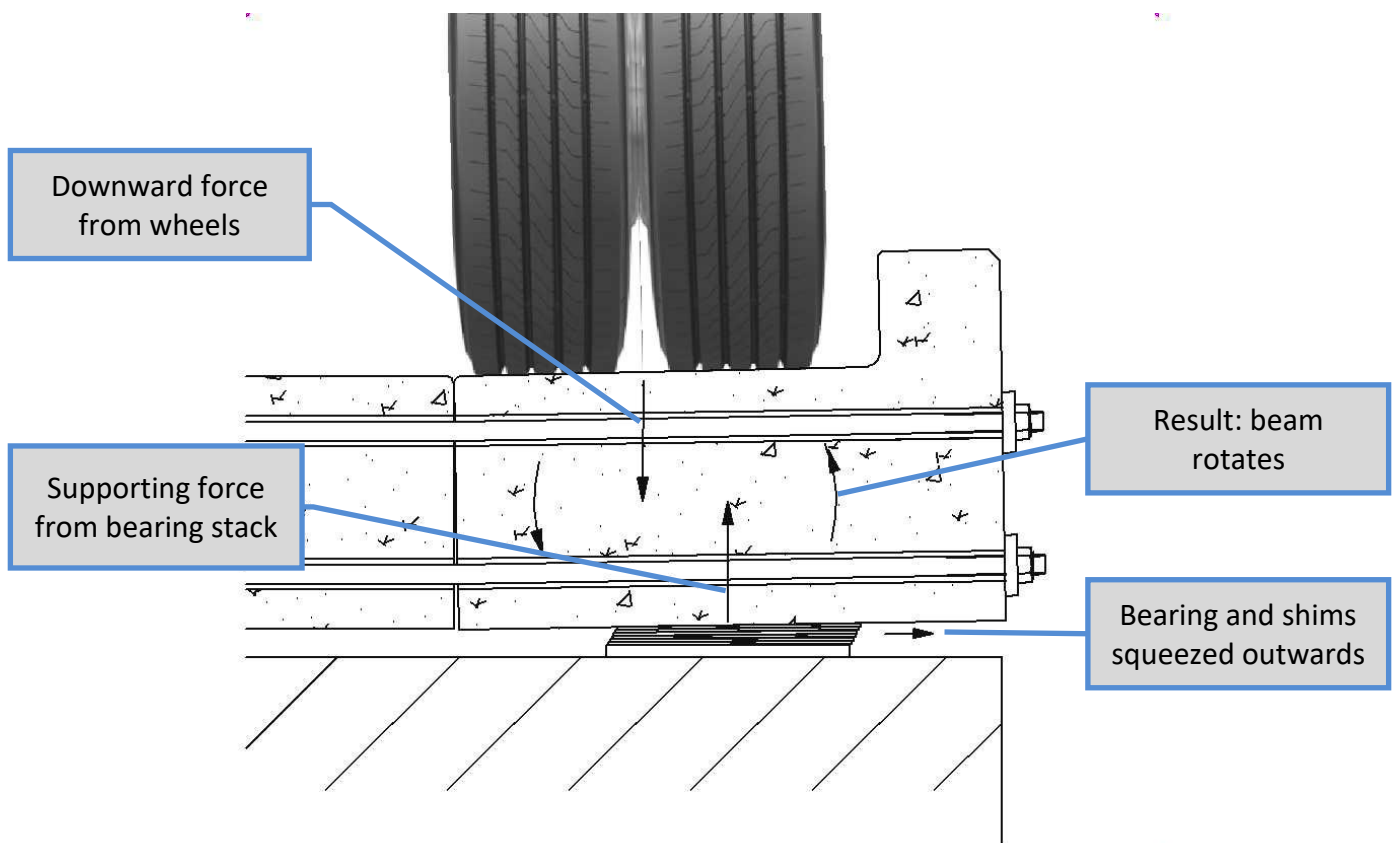
Figure 6c: Detail, showing turning moment created by loaded wheels. The bottom of the beam rolls outward. The beam is partly constrained by the retaining bolts, but the bolts stretch and allow the stack to slide.

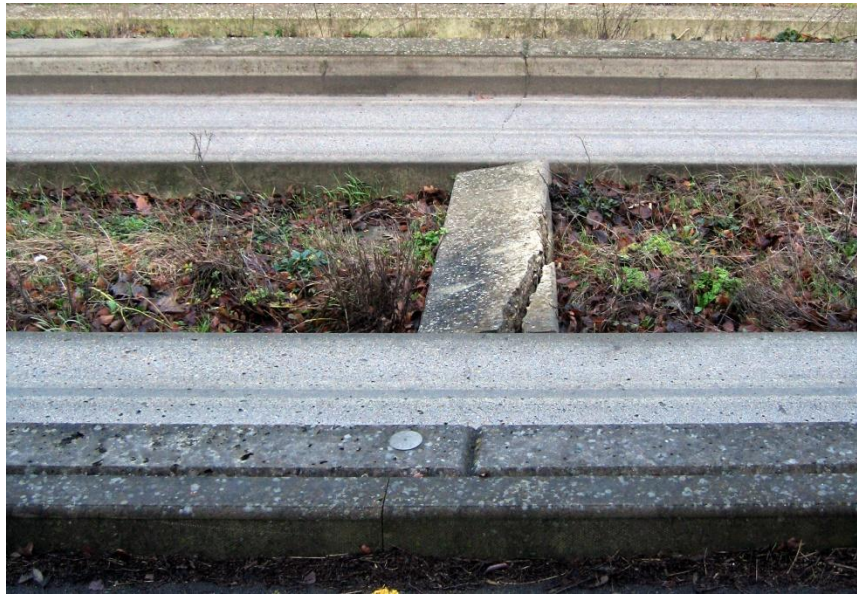
*Fig 7: Fractured centre spacer. The spacer has pitched forward. The top of the beams have apparently rolled inward and pinched the spacer, as indicated in Fig 2c, above, resulting in fractures at both ends.*

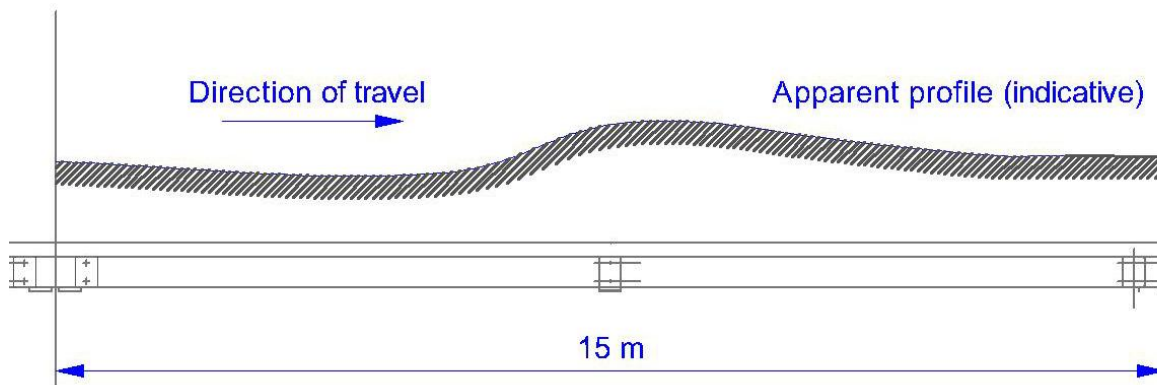
Figure 8: Indicative profile of the ride for extended sections of the Busway. The observed motion of the vehicle will differ from the profile of the beam, having been modified by the vehicle suspension.

We note comments regarding heave, particularly in relation to shrinkable clay and trees [2 – p58 para 187]. However, the ‘hopping’ occurs over extended lengths of the Busway. The geology is varied, but the phenomenon is apparent over significant stretches of the route, and we suggest that a mechanism other than shrinkage and heave may be present.

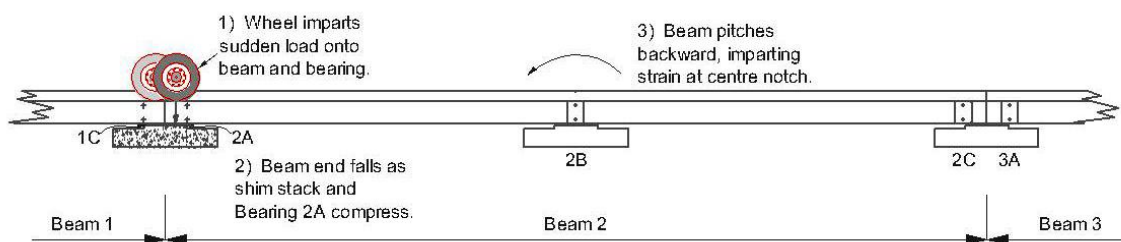
Figure 9: Action and reaction of a beam as it receives an impact from a loaded wheel.

With an 18 tonne dual axle bus approximately 3.5t is taken on each of the front wheels. With the wheel at the end of Beam 1, the load on 1C is a total of 7.3t (beam with bus), and the load on 2A is 3.8t (beam alone).

**We suggest that a significant reason for cracking is cyclical percussive loading as bus wheels hit the start of each beam.**

**We suggest that a significant reason for differential settlement of the foundations is because of percussive loading by wheels as they impact the start of the beam. The loading on the centre foundation is much smoother by comparison.**
